# Two Carats

## ALOHA 8.2 COMPLETE REFIT

*This story is about the refit of a 1986 Aloha 8.2 purchased on EBAY for \$2800.00 from a marina in Maryland.*

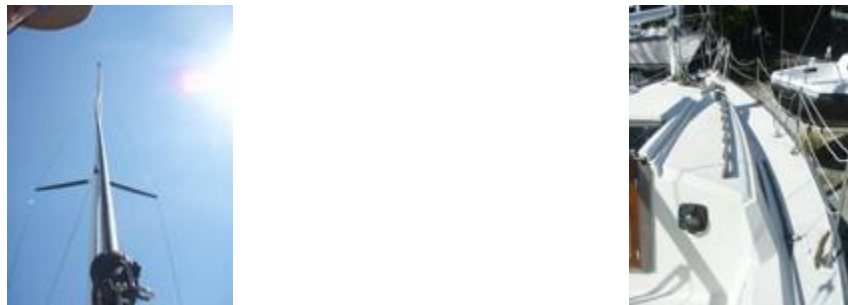
Structurally, the gel coat showed signs of being beat up by the sun and there were large cracks in the gel coat on the starboard side of the boat. I was worried that the boat had hit ground and been washed up at one point and ended up resting on the starboard side. I don't think this is the case. The boat yard indicated that the gel coat had been applied too thick in the mold and resulted in it becoming brittle with age.

I did find cracks inside the port side settee locker and repaired this with fiberglass.

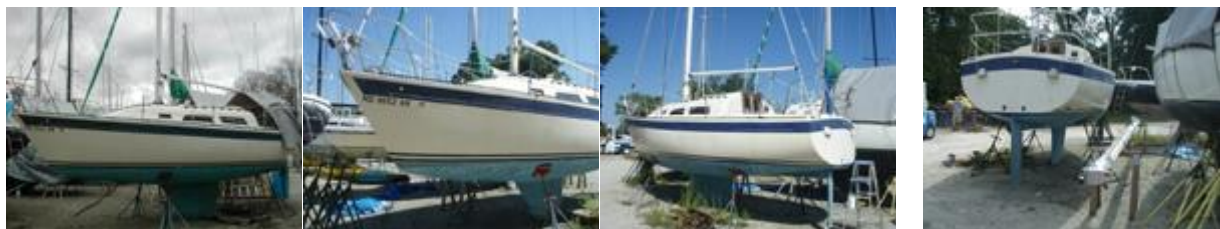
In general, the boat looked decent on the web but up close, it had many cracks in the gel coat and the water line was uneven. There had been many coats of anti-foul applied to the hull. I expected to refinish the hull and topsides when I purchased the boat.

The gunwales were very damaged and cracked and I decided to have them repaired and painted with an off-white to match the decks as close as possible. The whole boat was stripped and the cracks were ground out of the topside and filled with epoxy. The topsides were sanded down enough to reduce the thickness of gelcoat and then sprayed with awgrip epoxy.

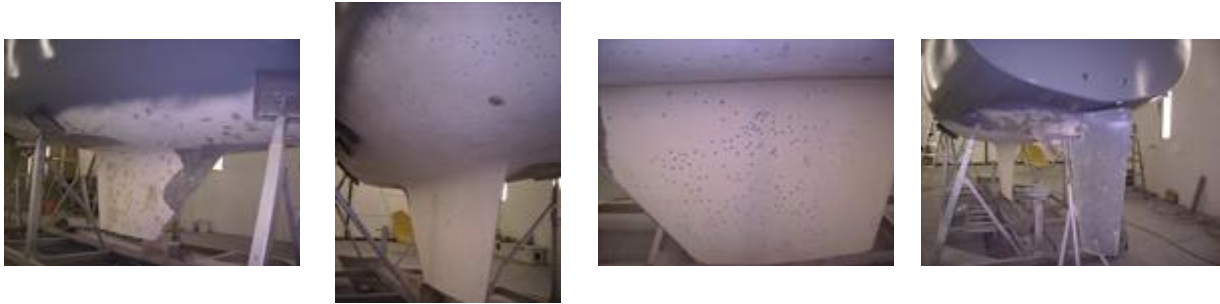
The hull was also stripped down to the original gel-coat and in some areas completely removed due to delamination or osmotic damage. The rudder was completely stripped down to the original finish. All small blisters were filled and then a high build immersion epoxy was used. (Interprotect 2000).

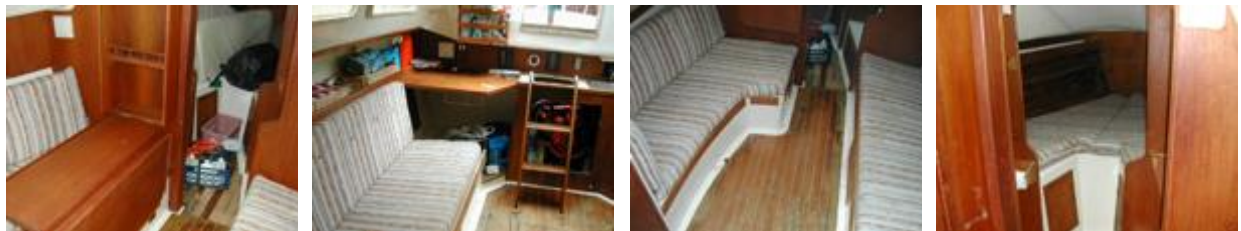
When I first entered the companion way, I saw immediate evidence that the interior had been full of water for an extended period of time. Likely a combination of water and diesel fuel. Some of the gel coat below the settees was bubbled from osmosis of water into the gel coat. I speculate that this was due to having wet cushions resting on the gel coat for an extended period. The floor was destroyed by water migration. It was stained and delaminating and not repairable.

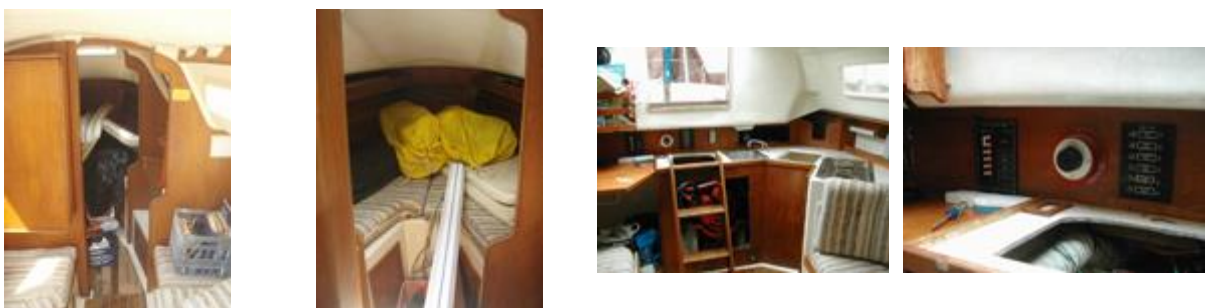
In the V-berth, there was evidence of leaking from above. The port side of the V-berth was black and the wood was in poor condition. Behind the anchor locker access, I found heavy black mold covering the fiberglass.
