# Two Carats

## ALOHA 8.2 COMPLETE REFIT

*This story is about the refit of a 1986 Aloha 8.2 purchased on EBAY for \$2800.00 from a marina in Maryland.*

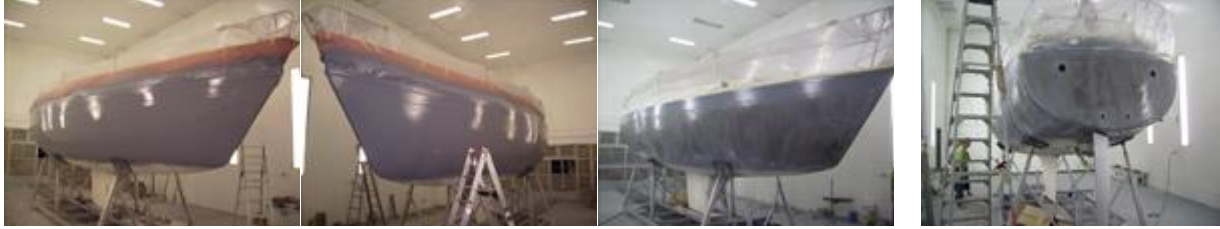
The gunwales were very damaged and cracked and I decided to have them repaired and painted with an off-white to match the decks as close as possible. The whole boat was stripped and the cracks were ground out of the topside and filled with epoxy. The topsides were sanded down enough to reduce the thickness of gelcoat and then sprayed with awgrip epoxy.

They used high-build epoxy so the topsides could be faired as smooth as possible. Since the colour was going to be flag blue, the preparation was more stringent so the imperfections were reduced to minimal. They used the carbon powder during the fairing process to ensure the surface was as smooth as it could be.

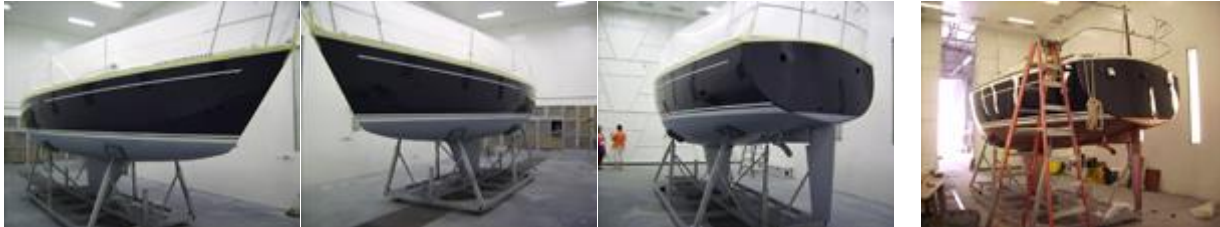
The hull was also stripped down to the original gel-coat and in some areas completely removed due to delamination or osmotic damage. The rudder was completely stripped down to the original finish. All small blisters were filled and then a high build immersion epoxy was used. (Interprotect 2000).

I am impartial to flag blue and really liked the white stripe configuration. The bottom was done with VC-17 anti-foul.

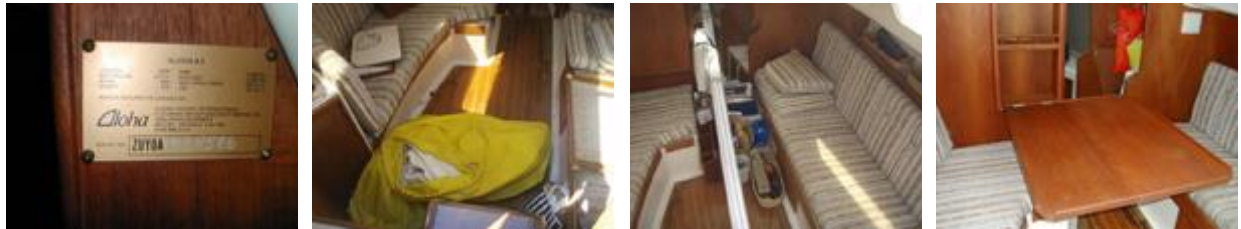
When I first entered the companion way, I saw immediate evidence that the interior had been full of water for an extended period of time. Likely a combination of water and diesel fuel. Some of the gel coat below the settees was bubbled from osmosis of water into the gel coat. I speculate that this was due to having wet cushions resting on the gel coat for an extended period. The floor was destroyed by water migration. It was stained and delaminating and not repairable.

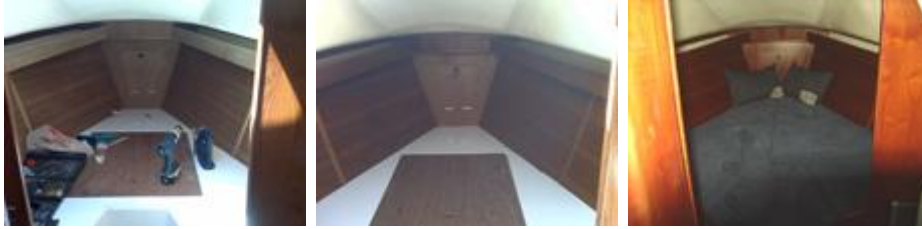
The v-berth wood was in really poor condition. The wood had rotted right out at the bulk head and mold had proliferated all through the bow area.

Once everything was cleaned out and repaired, I decided to replace the interior with teak laminate. I did not glue anything and simply used the teak wood battens to fasten the panelling to the v-berth walls using brass screws. I was able to source everything at Noah's Marine in Toronto and have it shipped to my house.

I made patterns for the walls and cut them at home before I brought them down to the boat. Every other component was templated from the original wood that was removed.

I used 1/4" round to trim up edges and hide any imperfections.

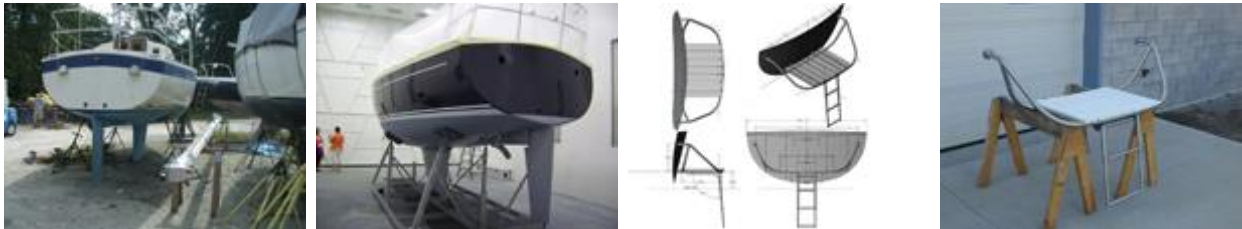
When I purchased the boat, there was no ladder mounted to the stern. The previous owner had welded a section across the stern pulpit to accept a ladder however, the one sent with the boat was damaged and not worth repair.
